## **Cape Breton Regional Municipality + You. Moving Accessibility Forward.**

**Final Accessibility Action Plan for the Cape Breton Regional Municipality (CBRM)**

**Submitted by: reachAbility Association**

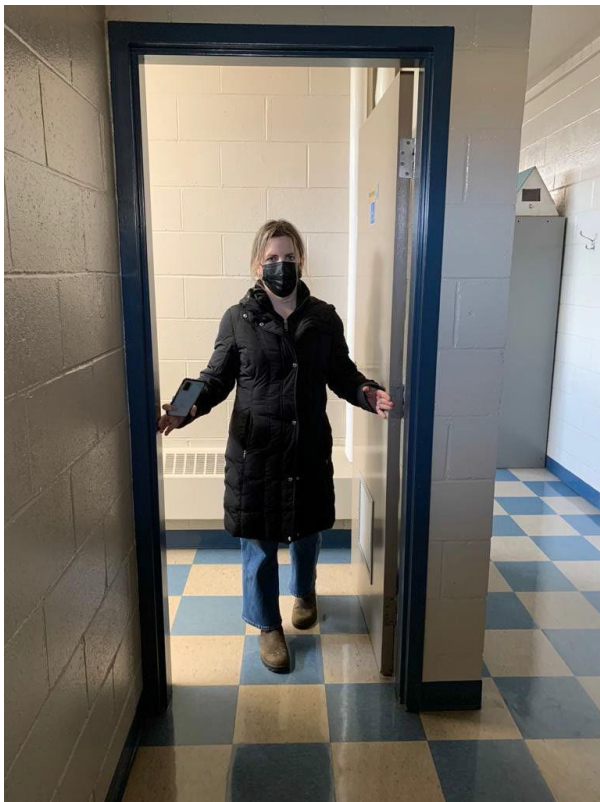
- Narrow doorways.
- Insufficient signage and wayfinding.
- A lot of clutter near the entryway.
- Heavy doors.
- Accessible viewing area for the pool, but narrow hallway with odd barriers in passageway caused by structure of wall/ductwork in order to get to the viewing area.
- Very little signage or wayfinding anywhere.

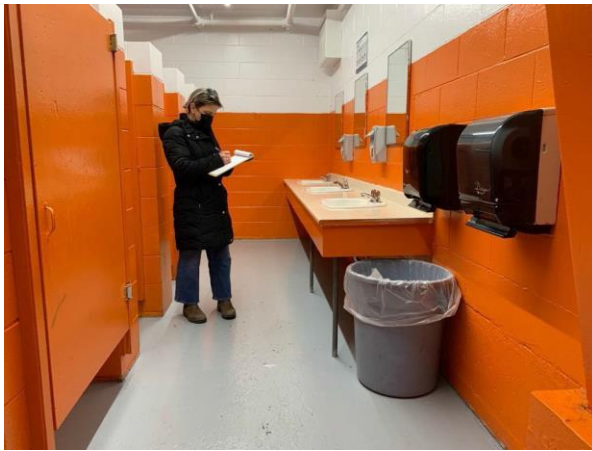
- Bathroom stalls not accessible widths for accessibility and passageways do not provide enough turn radius or room for travel.
- Sinks are not accessible. Removing the trim around the front and sides of the vanity would provide appropriate knee clearance of 685 mm.
- Bathroom doorways are too heavy.

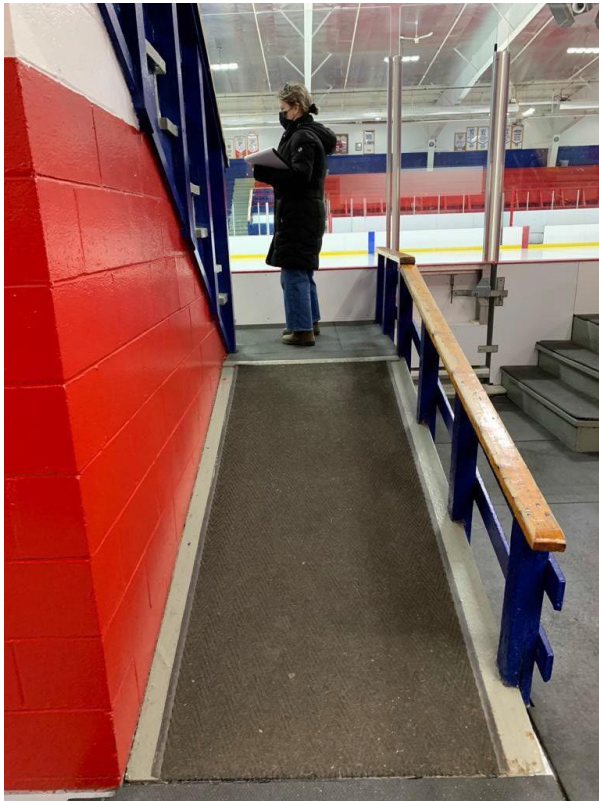
- Ramp provides access to rinkside accessible seating but ramp is not to code. The incline is above the 5-6% maximum and the railing is below the appropriate height, by almost half.
- Contrast is needed on the ramp and on all stairs.
- Changing rooms could be adapted to accommodate an accessible shower by moving the stall wall out another 8-9" which is possible to do in its current state.
- AED is too high. It is currently approximately 1700 mm high and the maximum height should be 1100-1200 mm
- The box office and canteen counters are too high.
- Stairs do not have adequate contrast, tactile indicators or railings.

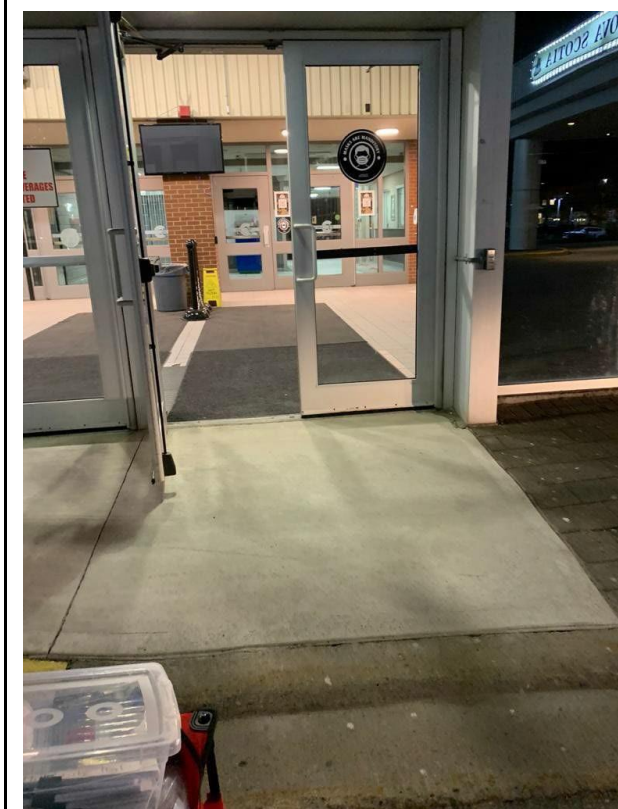
- There are no visible rinkside accessible seats.
- Rear entrance does not have door opener buttons.
- Entrance/Exit doors for the arena do not have door opener buttons.
- The main entrance has a slight incline in before the door open button and does not have enough space between the door and where the incline is for safe access.
- There is no safe passageway from the parking lot to the main entrance unless you travel from the Casino side of the building along the sidewalk, and this is a long way to walk with no rest areas.
- Wayfinding within the space could be improved.

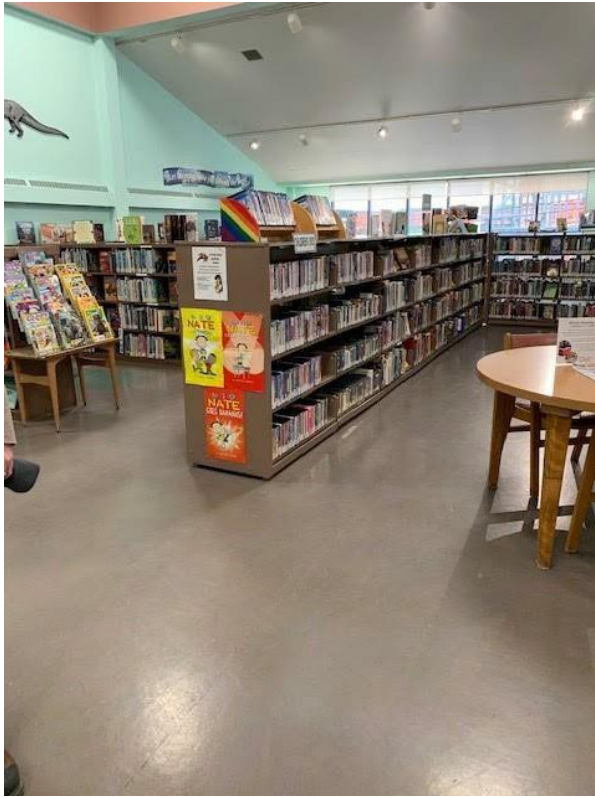
- The ramp to the main entrance is too steep, the railings are not to code, and it needs a landing area for rest.
- The main library space is too cluttered to allow for accessible passageways.
- There were benches in each aisle of books causing a barrier for anyone using a mobility device or wheelchair when trying to access the books.
- Most of the bookcases were too high in the main library area and should model the same height as the bookcases in the children/youth section.
- The book sale area is too crowded for able bodied people to move around let alone someone in a wheelchair.

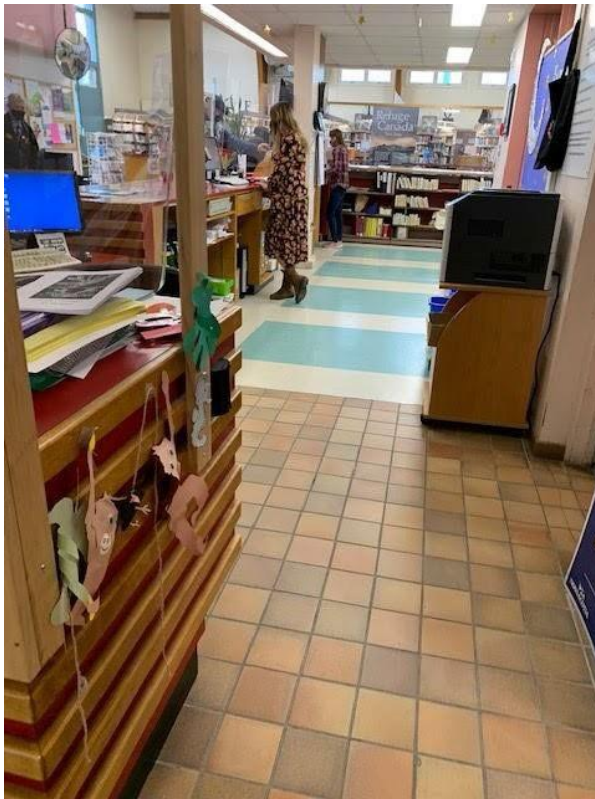
- The counters at the library staff work space are too high for accessibility.
- There is no elevator providing accessible access to the lower level which serves as the headquarters for the Cape Breton Regional Libraries.
- The entrance/exit to the lower level is also not accessible.
- Fire extinguishers are not encased or recessed in the wall.
- The door opener buttons for the main entrance are almost hidden in their current location and should be more clearly labelled or moved.
- The stairs and ramps inside and outside need adequate contrast and tactile indicators at the top, bottom and on all stairs.

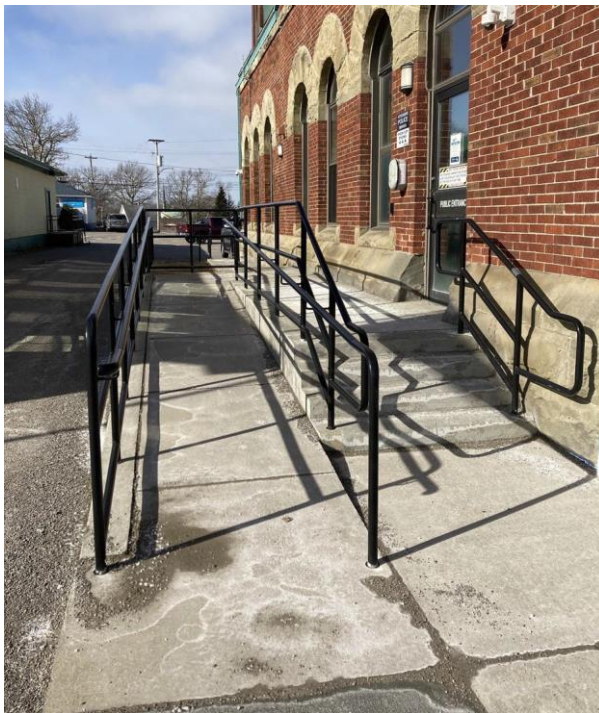
- The only room we could access was the lobby. The service window was at an appropriate height for a person using a mobility device. Plexiglass at reception makes hearing the reception officer difficult, even for persons without hearing loss. An intercom could be added that would allow the maintenance of the plexiglass shielding and mitigate communication barriers.
- The lobby had enough room to manoeuvre. A focus on a range of seating types would be a welcome addition to the space. For example, seats that provide adequate kick space to allow people to stand with ease.
- The ramp and stairs, as seen to the left, need contrast and tactile indicators.
