## **Cape Breton Regional Municipality + You. Moving Accessibility Forward.**

**Final Accessibility Action Plan for the Cape Breton Regional Municipality (CBRM)**

**Submitted by: reachAbility Association**

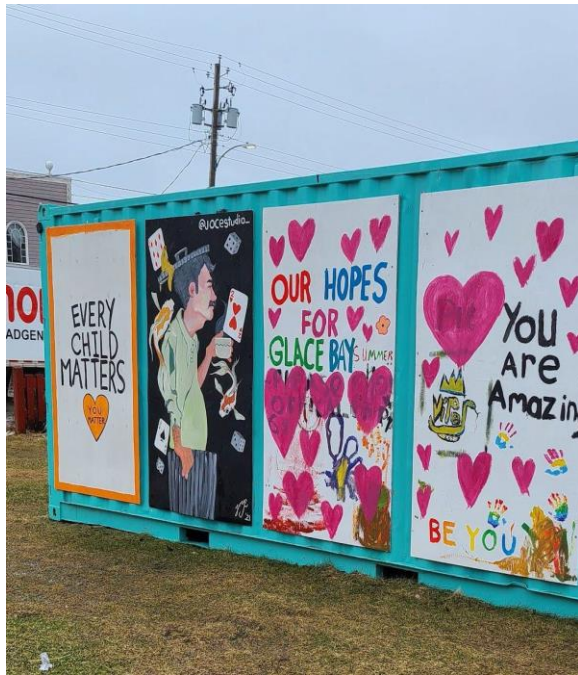
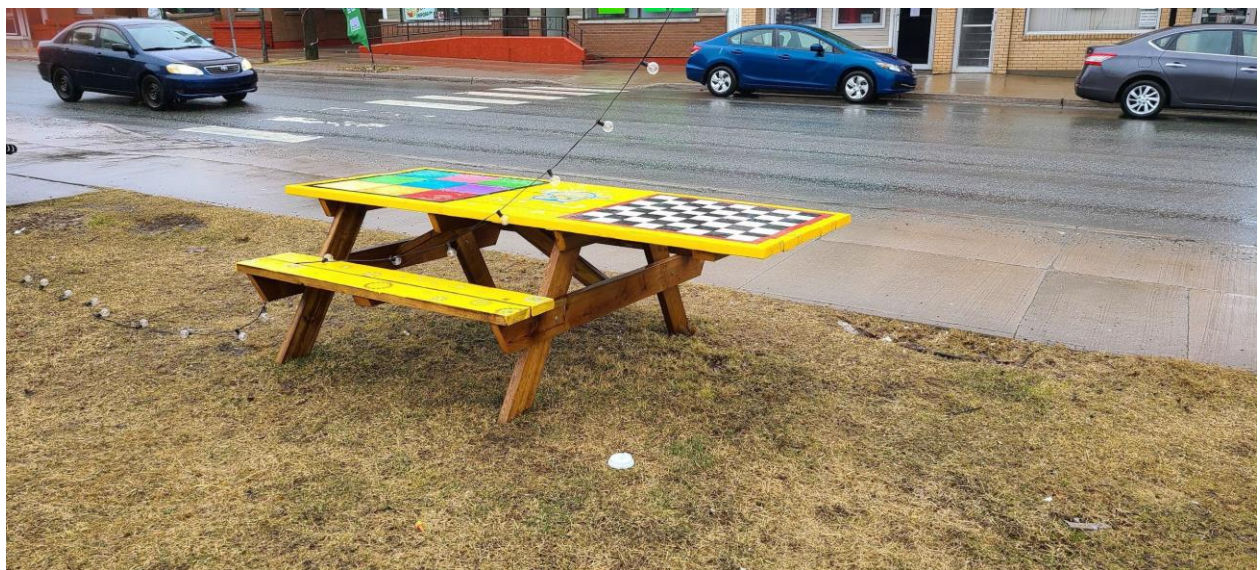
### Feature: **Commercial Street, Glace Bay**

The photos to the left and below are of a small public area across the street from the Glace Bay Library. The image to the left is of a storage container that is placed in between a small public parking lot and the sidewalk/crosswalk to get to the Library.

The photo below is of an accessible picnic table also located in the same public space with a string of clear patio style lights hanging across the image. We aren't sure who this space belongs to or what community initiative created the artwork but we were happy to see the space being embraced by and for the community.

We chose to feature this area as an example of how a space can, very inexpensively, be made inclusive, and accessible. The artwork here is community building, showcasing unity, acceptance and love for the entire community of Glace Bay.

The picnic table is close to the sidewalk making it more accessible to someone in a wheelchair and provides a rest area for folks who are out and about. It also offers a place to spend some time outside at no cost, enjoying a game with your friends with minimal supplies needed. We hope when the weather is better, this place will be brought back to life, the lights restrung and perhaps more spaces like this will be found throughout the region.

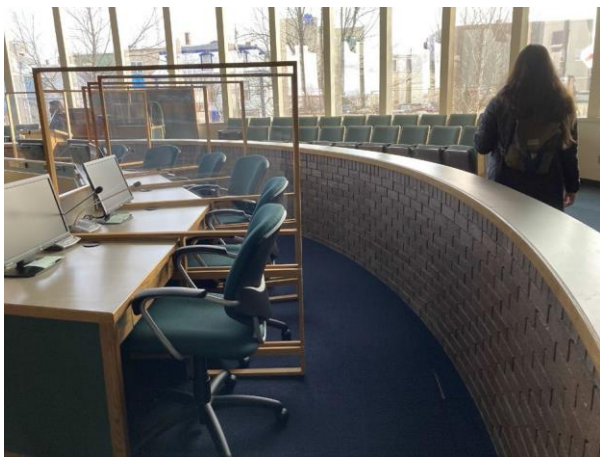
| | <p><b>Municipal Buildings</b><br/>CBRM City Hall - Council Chambers</p> <ul style="list-style-type: none"> <li>- Not enough space for accessible passage in the councillor seating area, plexiglass barriers impede movement.</li> <li>- Councillor tables/desks barely provide enough knee clearance.</li> <li>- Public seating area doesn't offer a variety of seating options.</li> <li>- Podium for public speaking is too high.</li> <li>- Media seating is inaccessible.</li> </ul> |

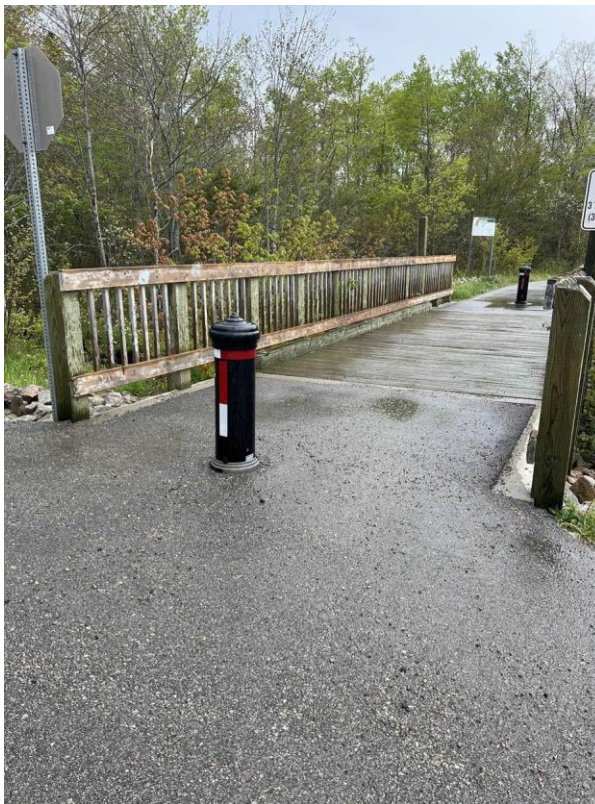
- No washrooms or waste receptacles along the first point of entry into the trail (approx the first 1km of the trail).
- Very accessible via wheelchair, walker, or other assisted mobile devices and equipment.

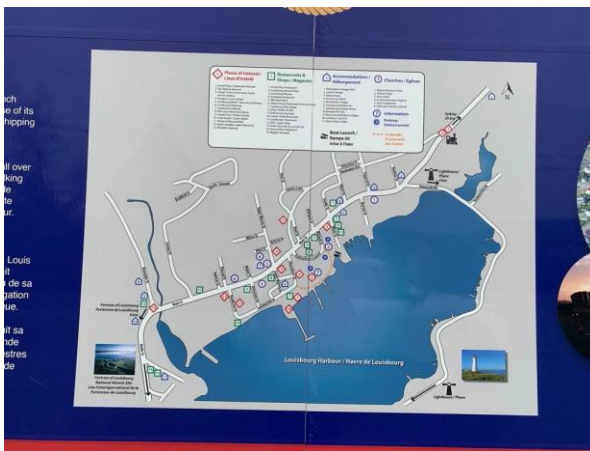
## Sidewalks, Crosswalks, Storefronts, and Signs Glace Bay

There are more sidewalks available in Glace Bay than most of the regions we visited, however the safe connectivity needs work.

- Sidewalks do not all have curb cut-outs at crosswalk intersections or where there are accessible parking spaces.
- There are curb cut-outs where one sidewalk ends and another begins, without marked crosswalks (no painted markings, posted signs, auditory or visual signals)
- There is insufficient wayfinding signage throughout the region, and Glace Bay is no exception. More effort needs to be made to provide needed information for the public to know where and how to find the essential services and amenities they require.

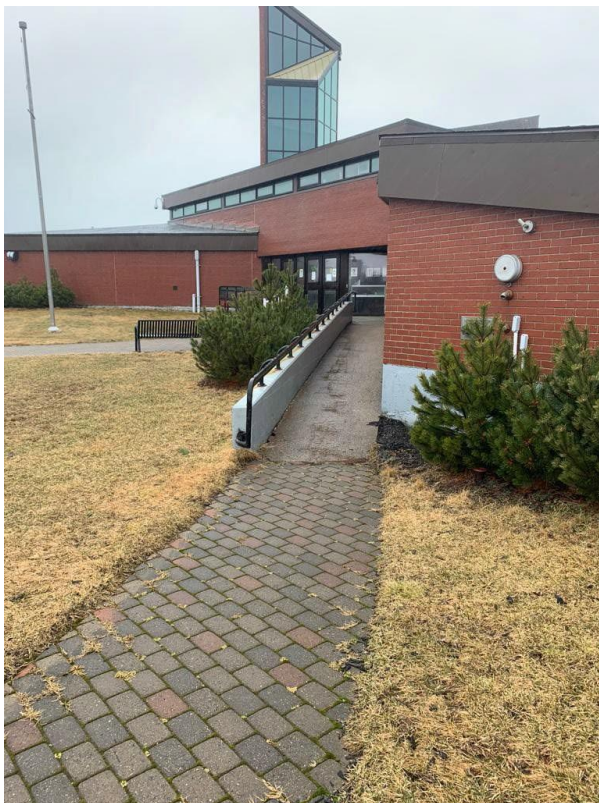
### **Miners Museum and Miners Memorial Park**

The park, in its current state, would not be passable for someone with a mobility disability. The ground is very unstable and uneven. Visitors enter through a rot iron archway passing over a gravel walkway into a grassy field type area. Visitors would benefit greatly from a wooden boardwalk being put here to allow for ease of access.

There are a number of large pieces of mining equipment throughout the area that are on exhibit with informative panels explaining their use in the mining industries. We would recommend the font be larger and with better contrast when, and if, they are ever replaced.
